**Draft Report  
Project No. 60251**

**Volume 1 of 5  
Remedial Investigation Report  
ACS NPL Site  
Griffith, Indiana**

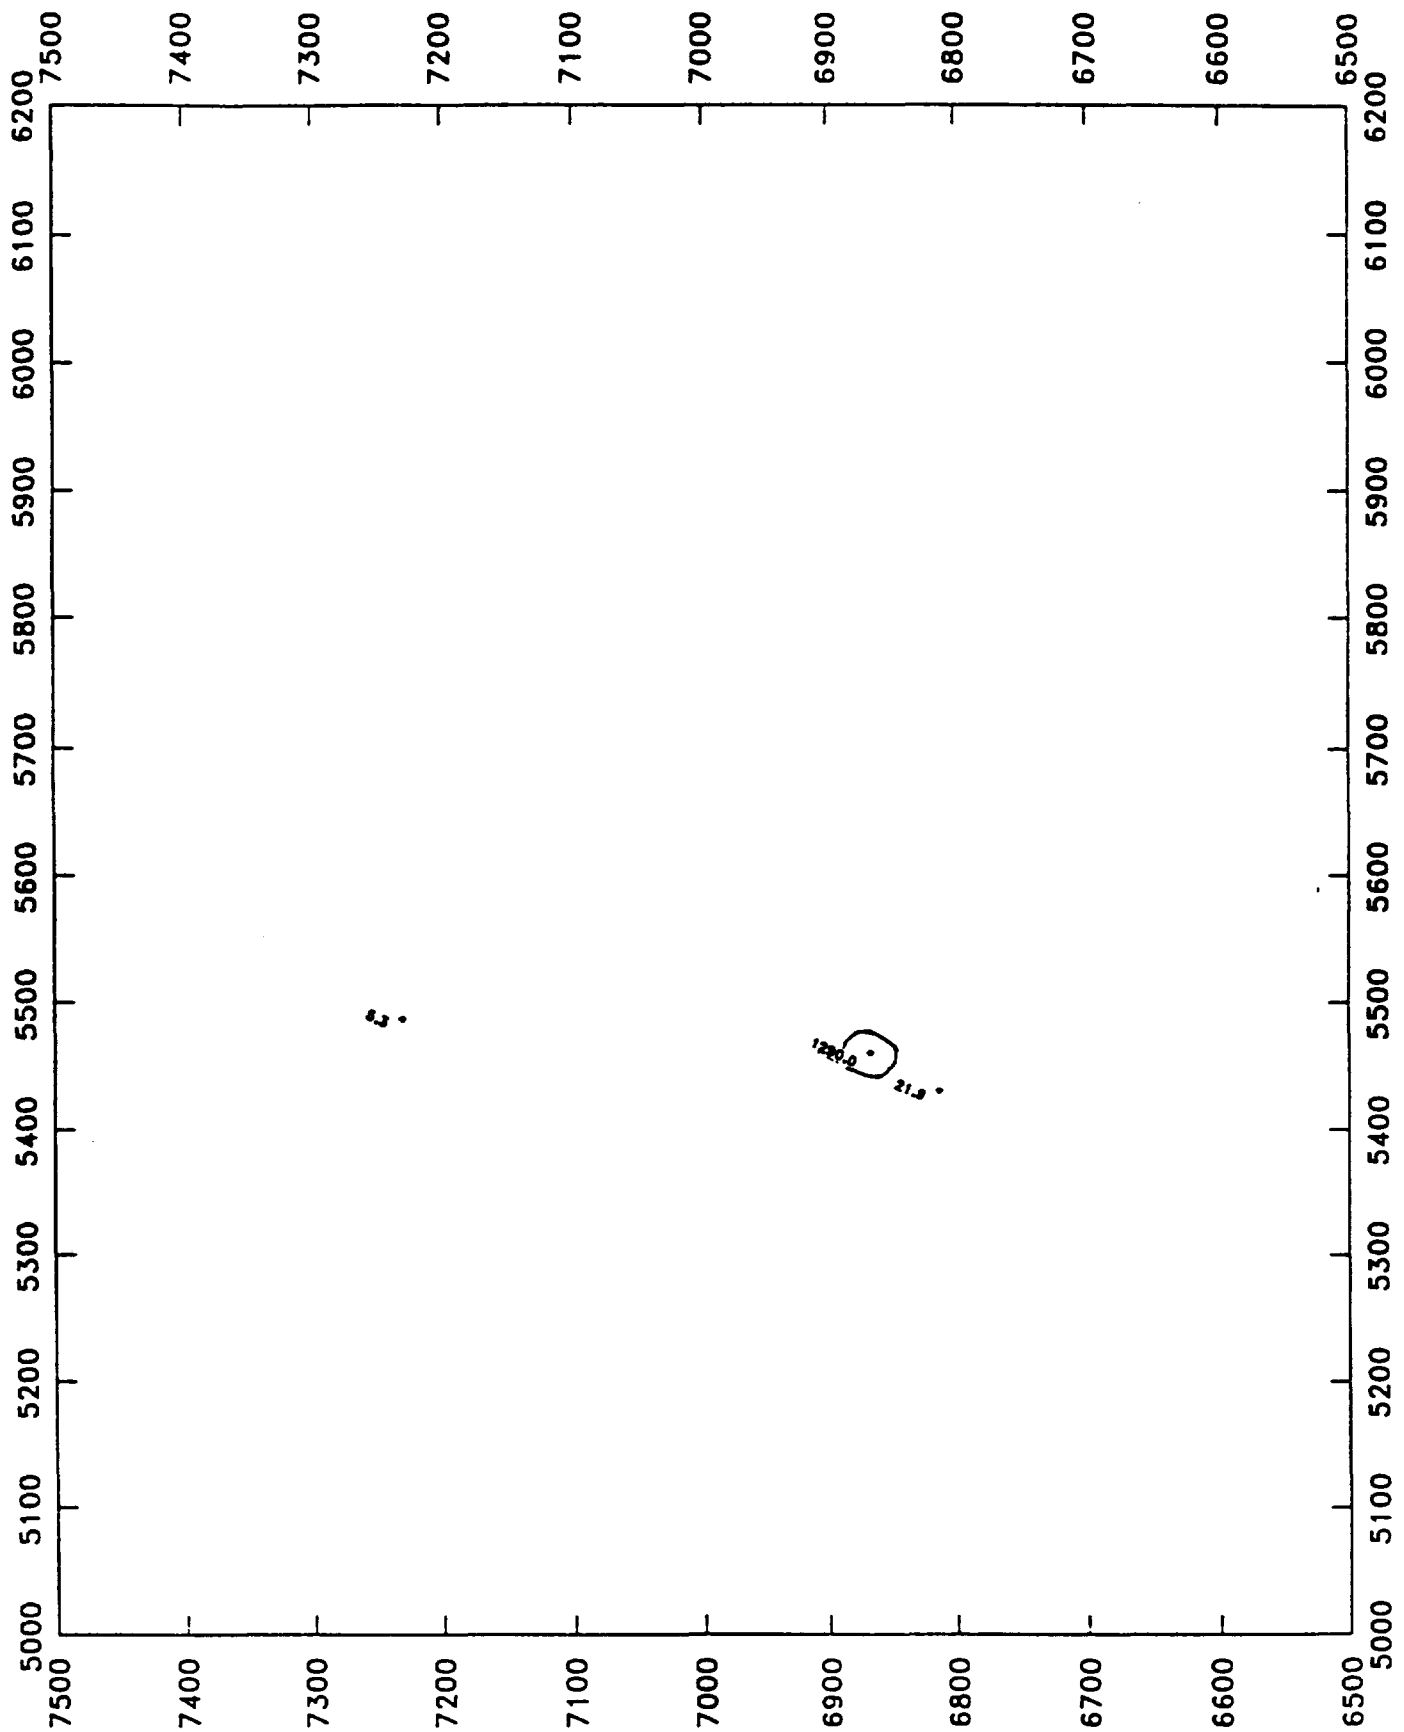
Figure 5-8d Approximate Extent of Lead Containing Wastes (> 500 ppm), On-Site Areas (10-15 feet below surface). Posted Values are in ppm (mg/kg).

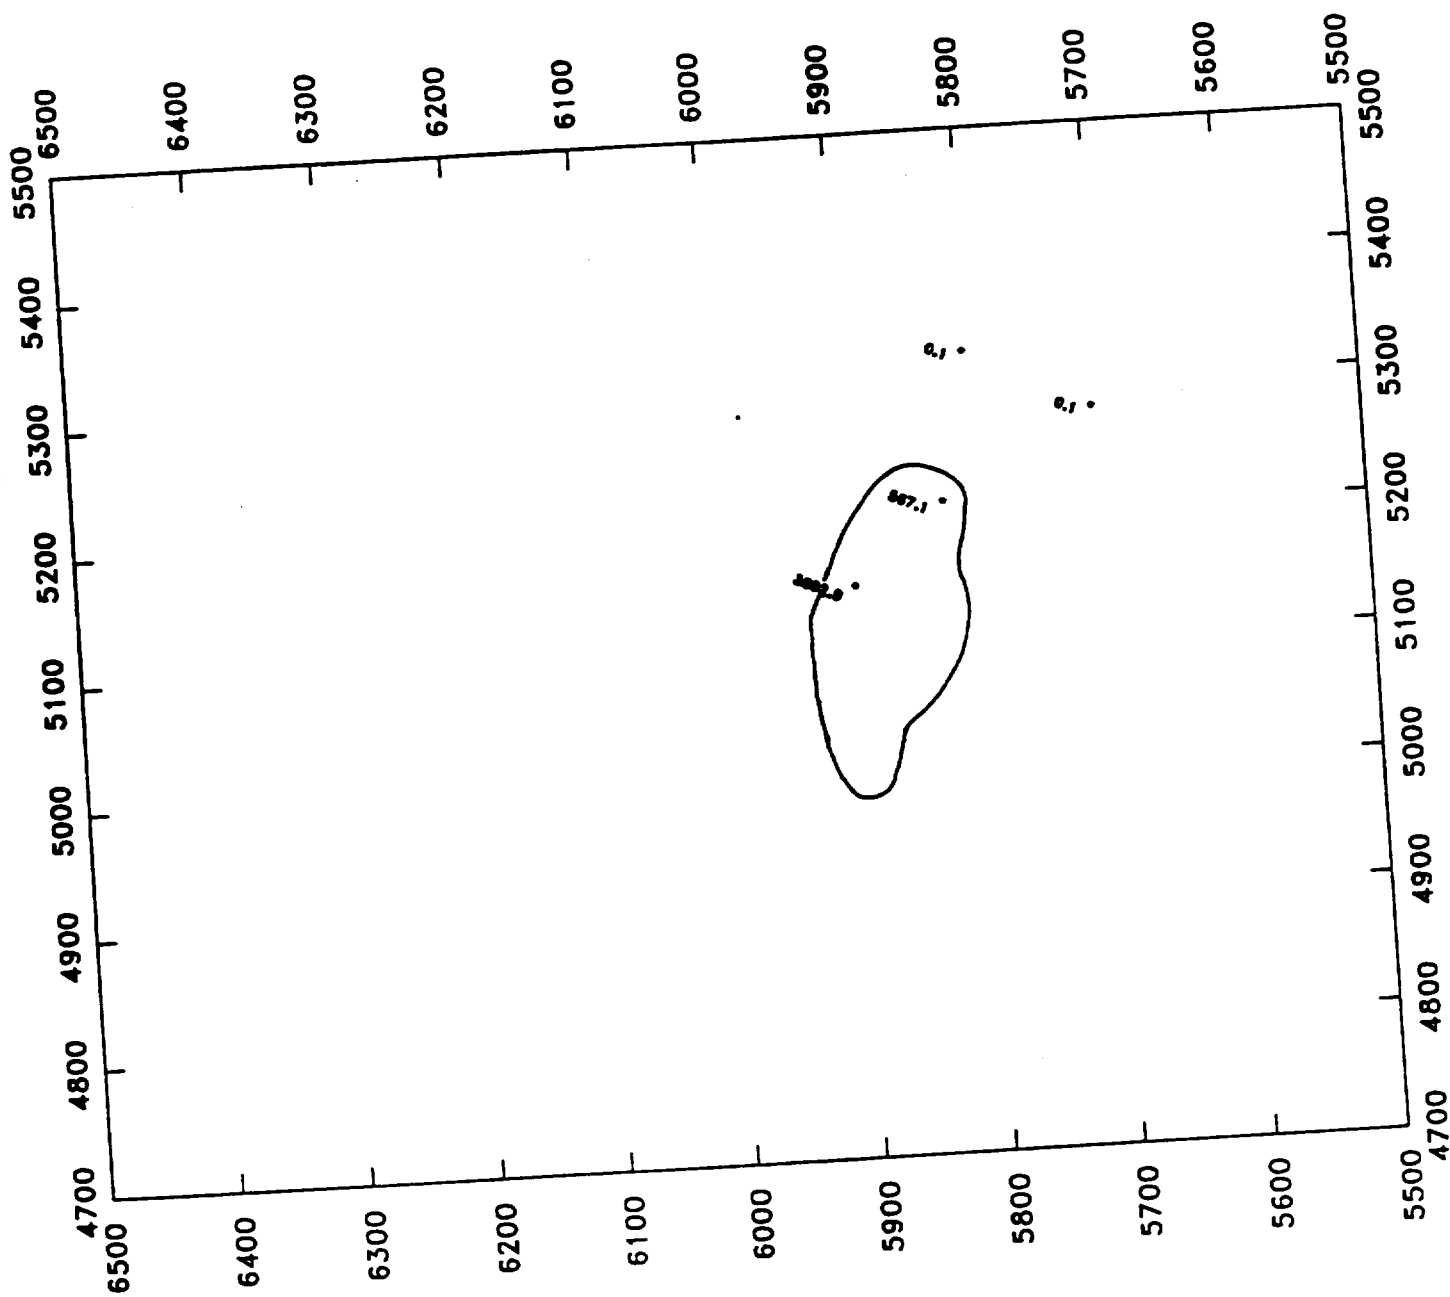
Figure 5-9c Approximate Extent of Total Volatile Wastes (> 1 ppm), Off-Site Areas (7.0 feet below surface). Posted Values are in ppm (mg/kg).

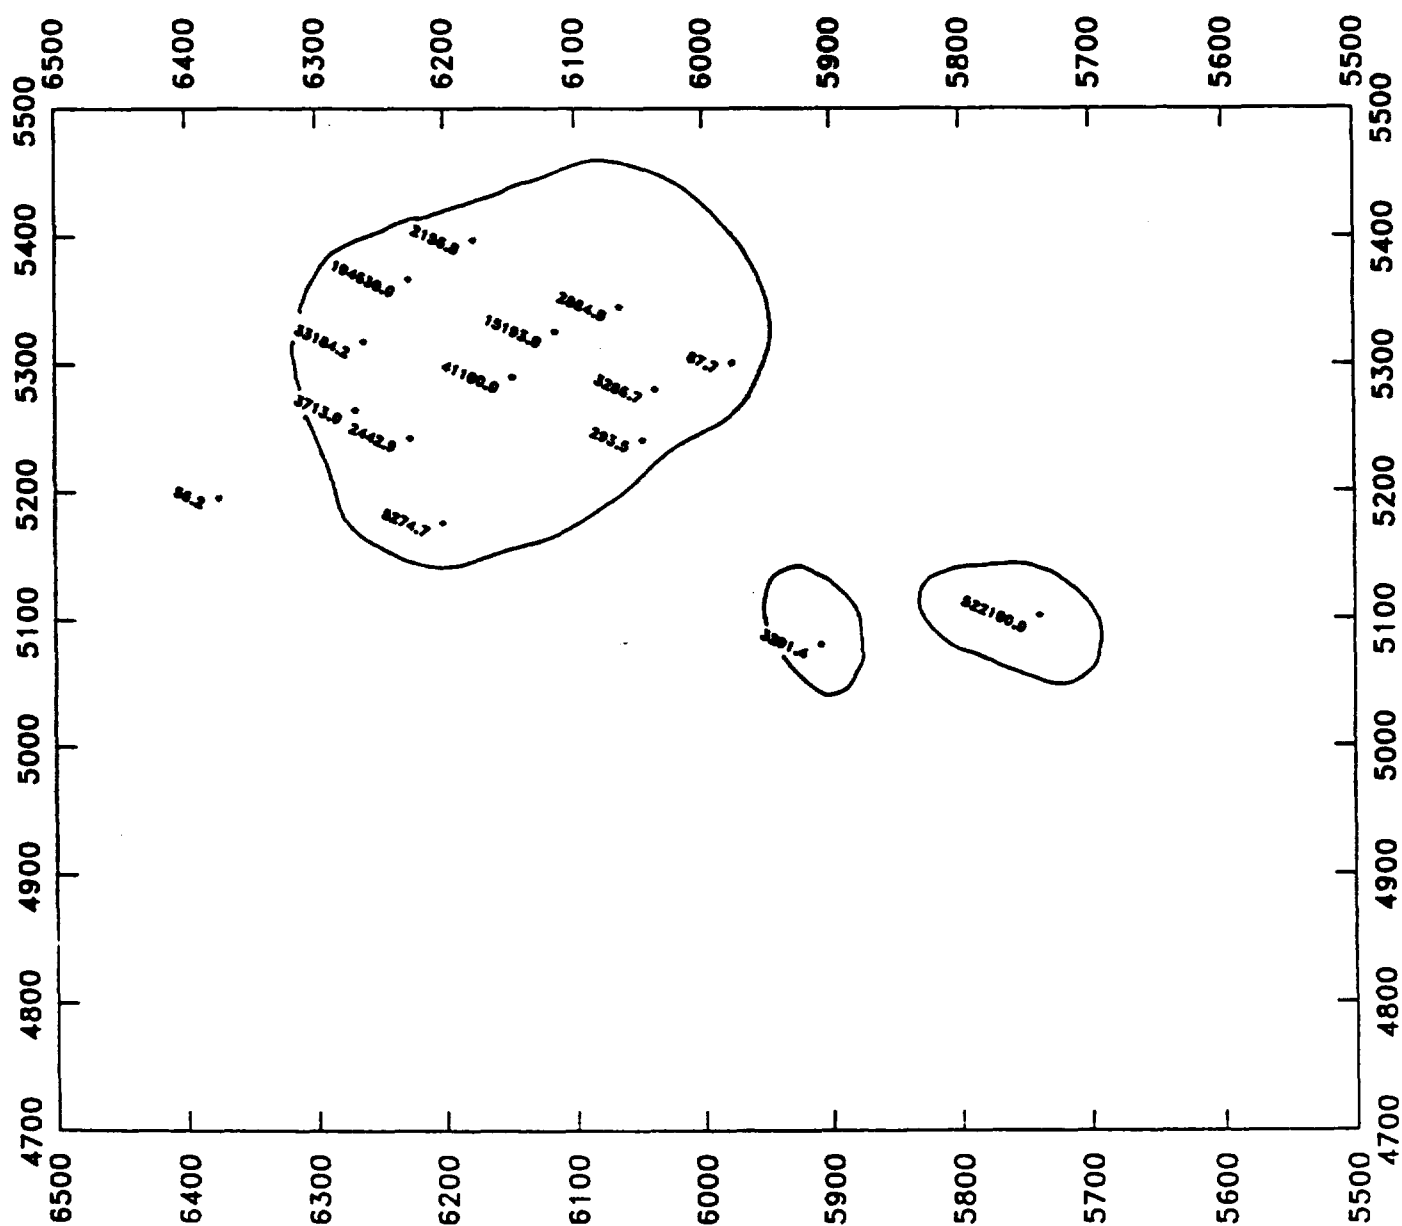
Figure 5-9d Approximate Extent of Total Volatile Wastes (> 1 ppm), Off-Site Areas (9-14 feet below surface). Posted Values are in ppm (mg/kg).

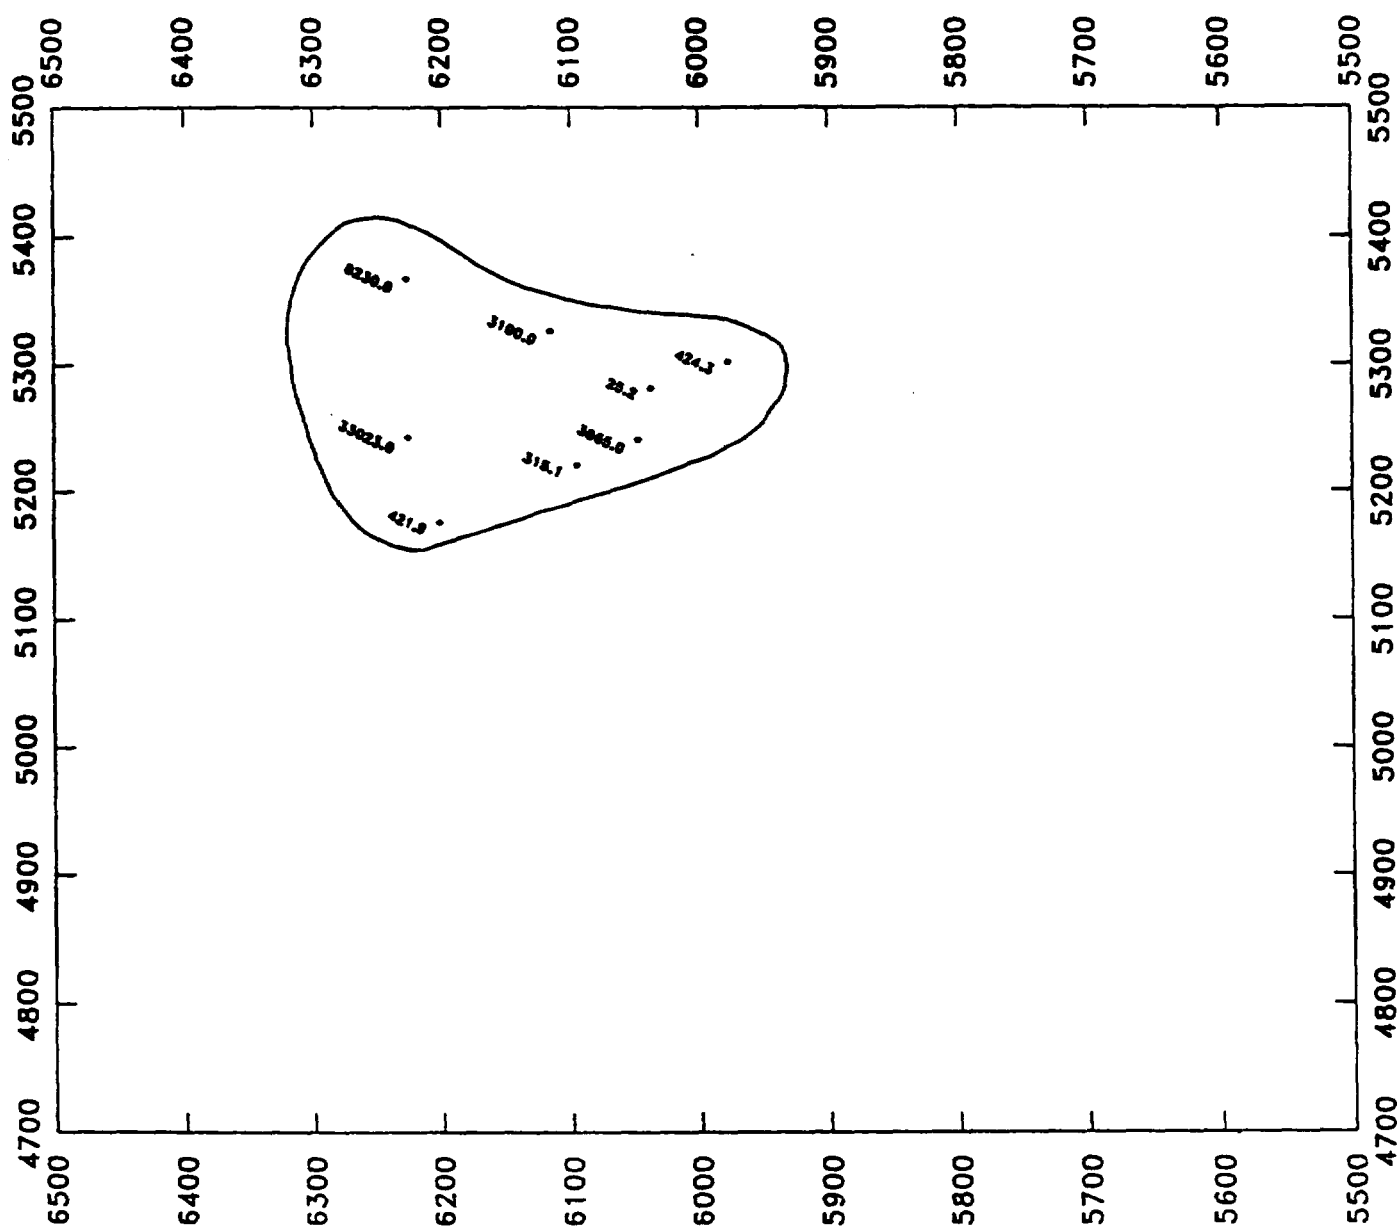
Figure 5-9e Approximate Extent of Total Volatile Wastes (> 1 ppm), Off-Site Areas (14-19 feet below surface). Posted Values are in ppm (mg/kg).

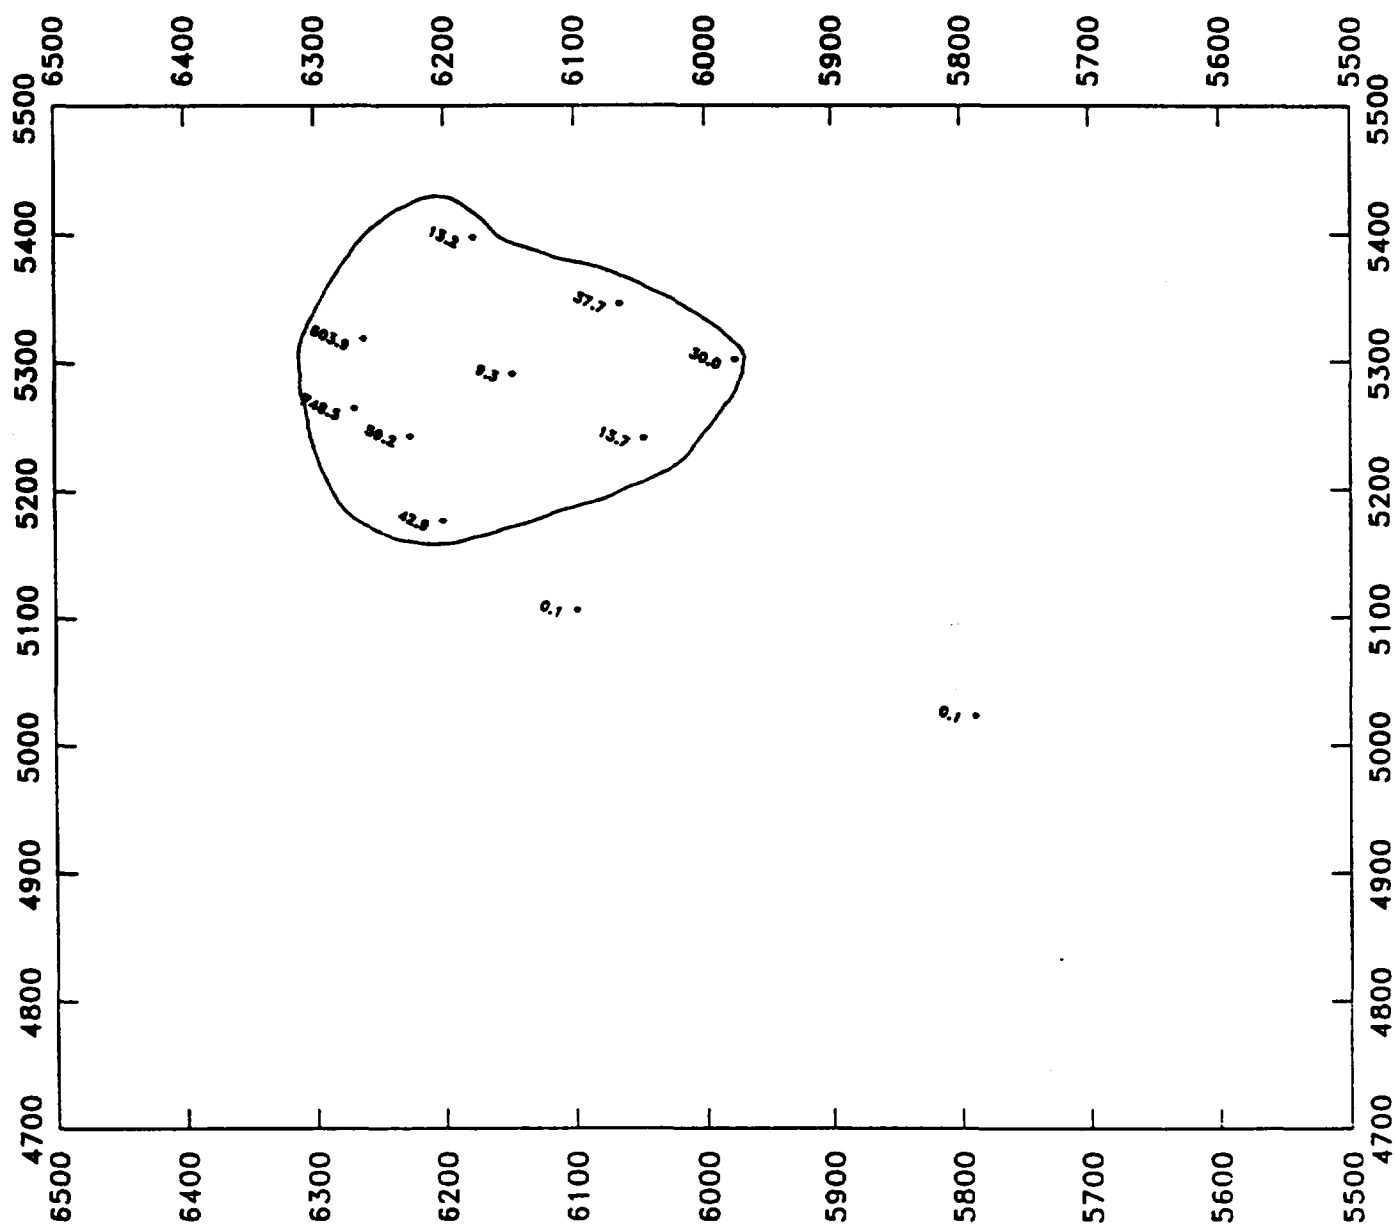
Figure 5-9f Approximate Extent of Total Volatile Wastes (> 1 ppm), Off-Site Areas (19-24 feet below surface). Posted Values are in ppm (mg/kg).

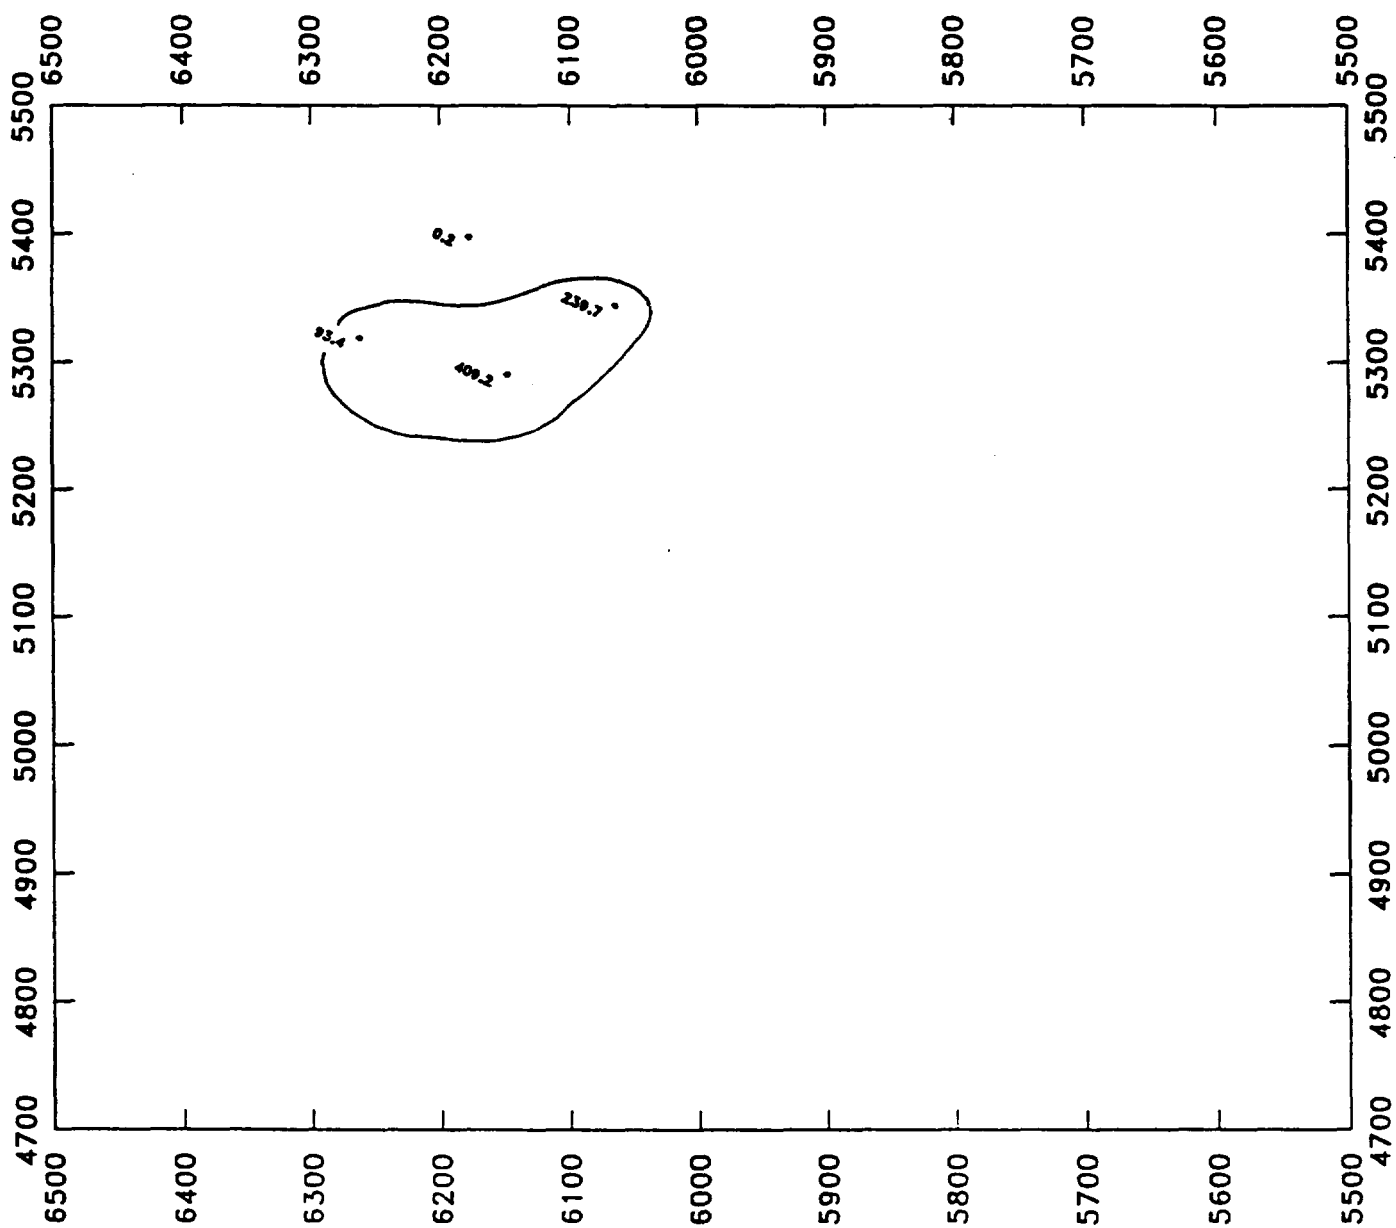
Figure 5-9g Approximate Extent of Total Volatile Wastes (> 1 ppm), Off-Site Areas (24-26 feet below surface). Posted Values are in ppm (mg/kg).

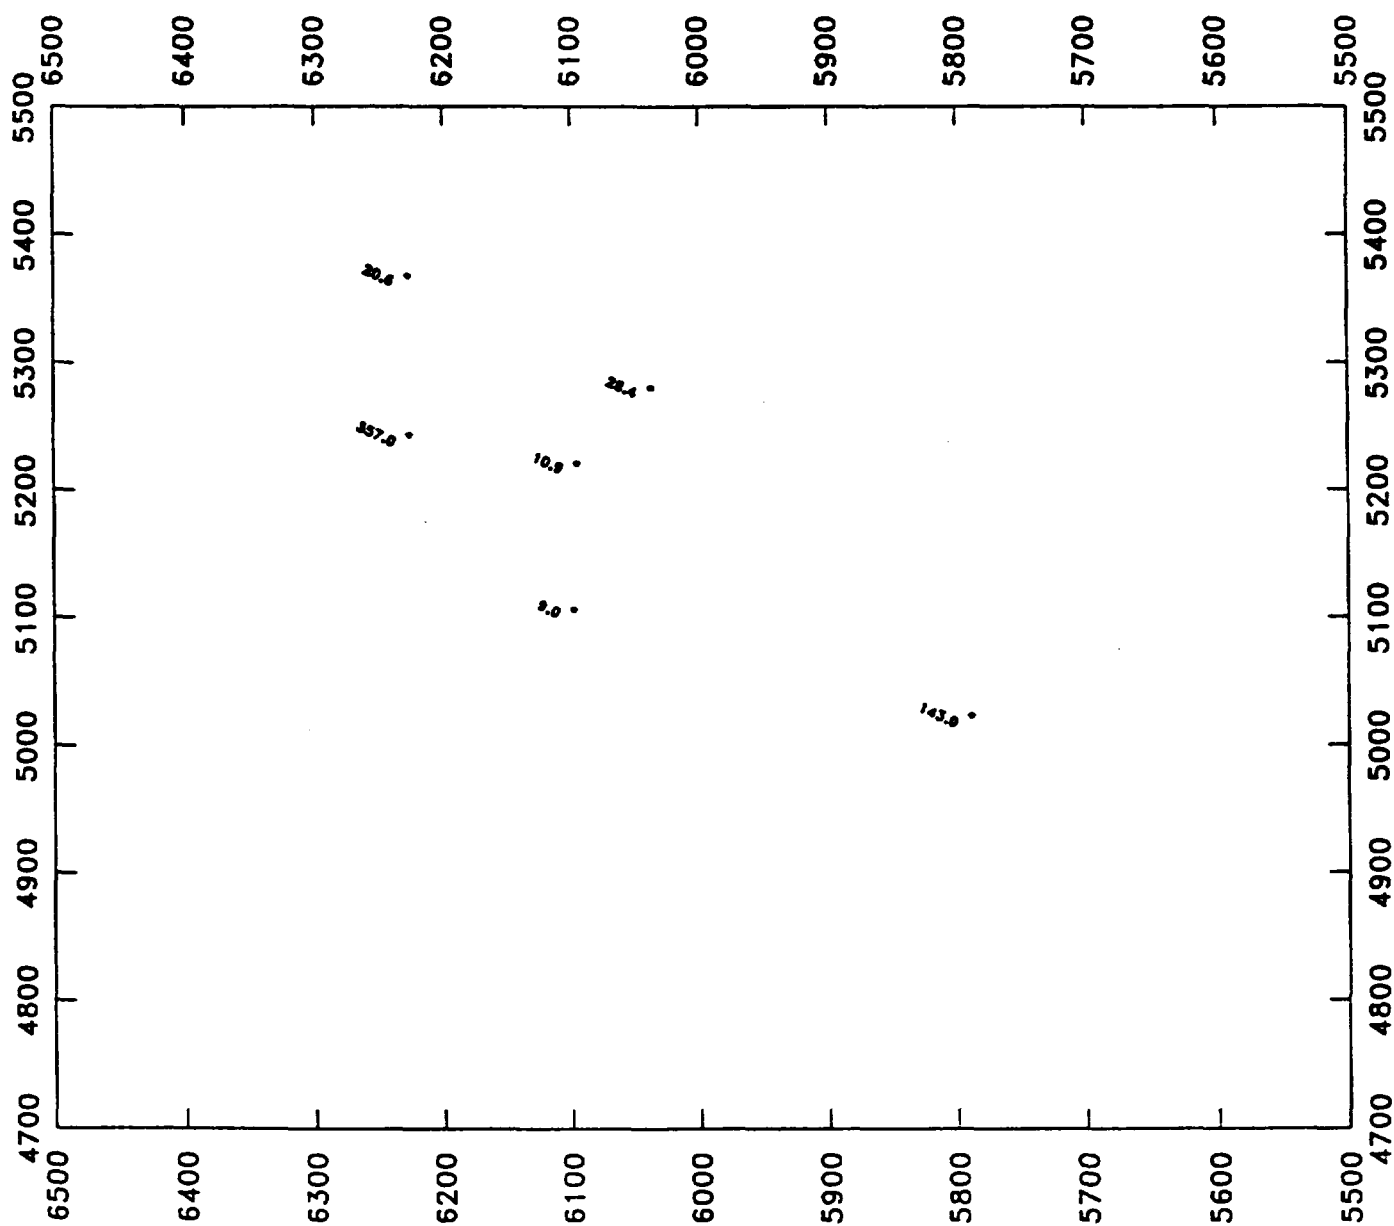
Figure 5-11e Approximate Extent of Lead Containing Wastes (> 500 ppm), Off-Site Areas (15-23 feet below surface). Posted Values are in ppm (mg/kg).

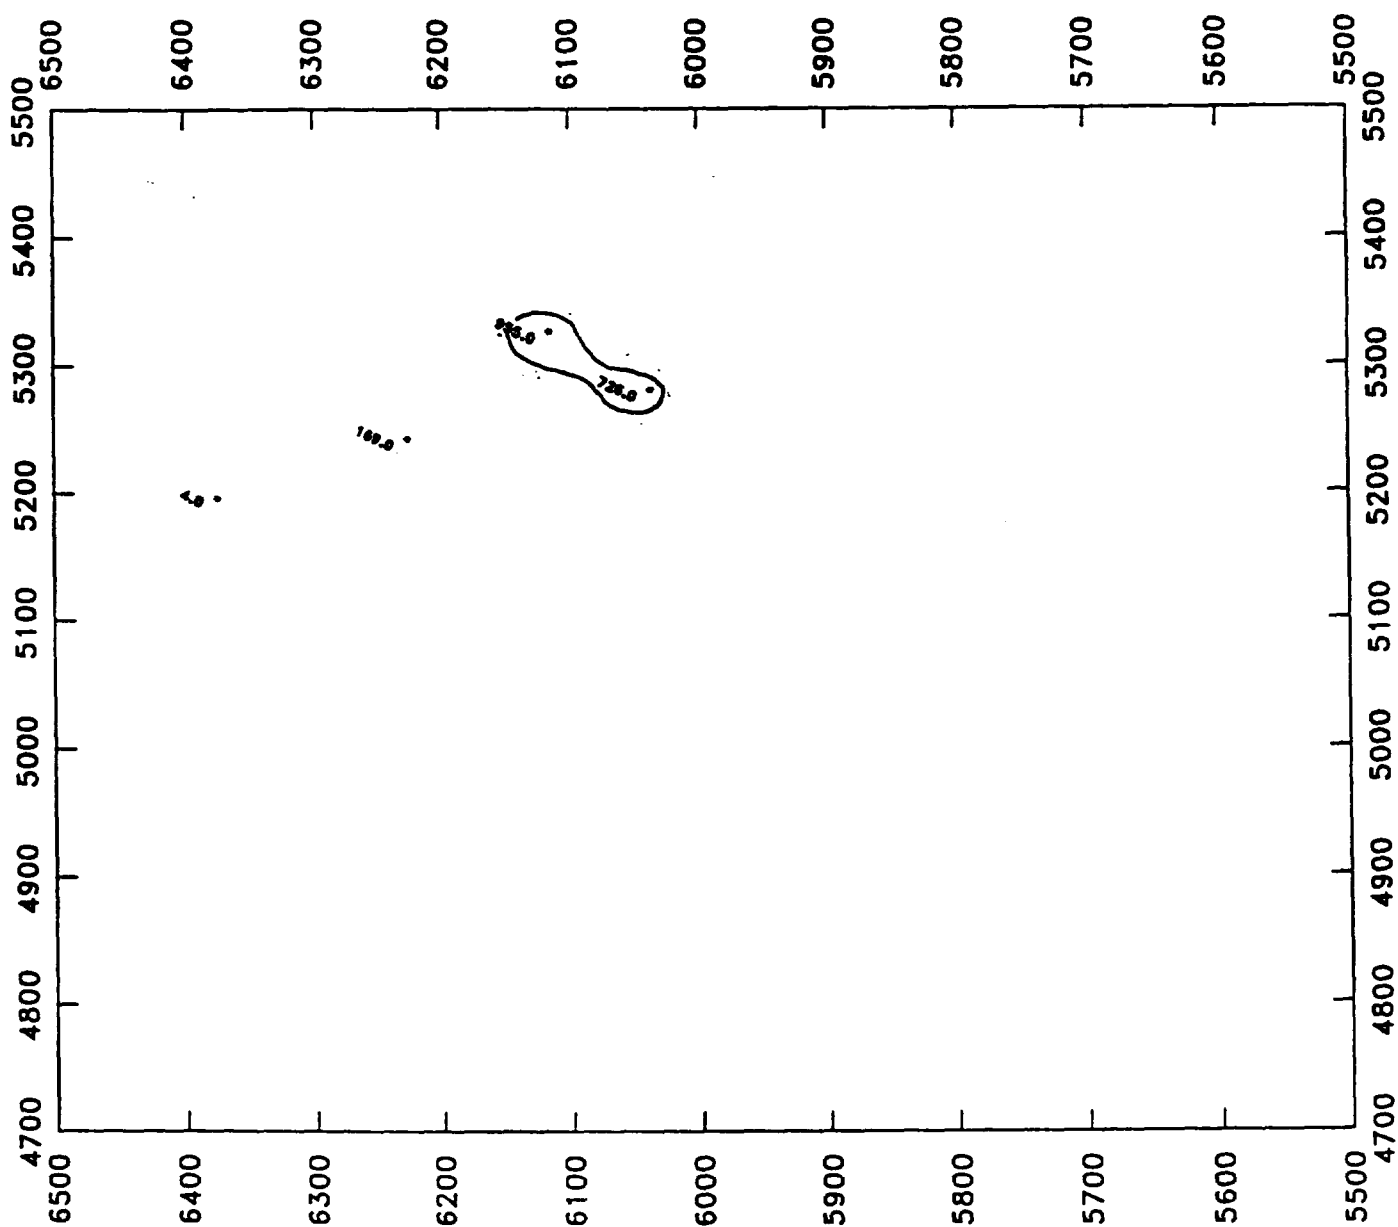
Figure 5-11d Approximate Extent of Lead Containing Wastes (> 500 ppm), Off-Site Areas (10-15 feet below surface). Posted Values are in ppm (mg/kg).

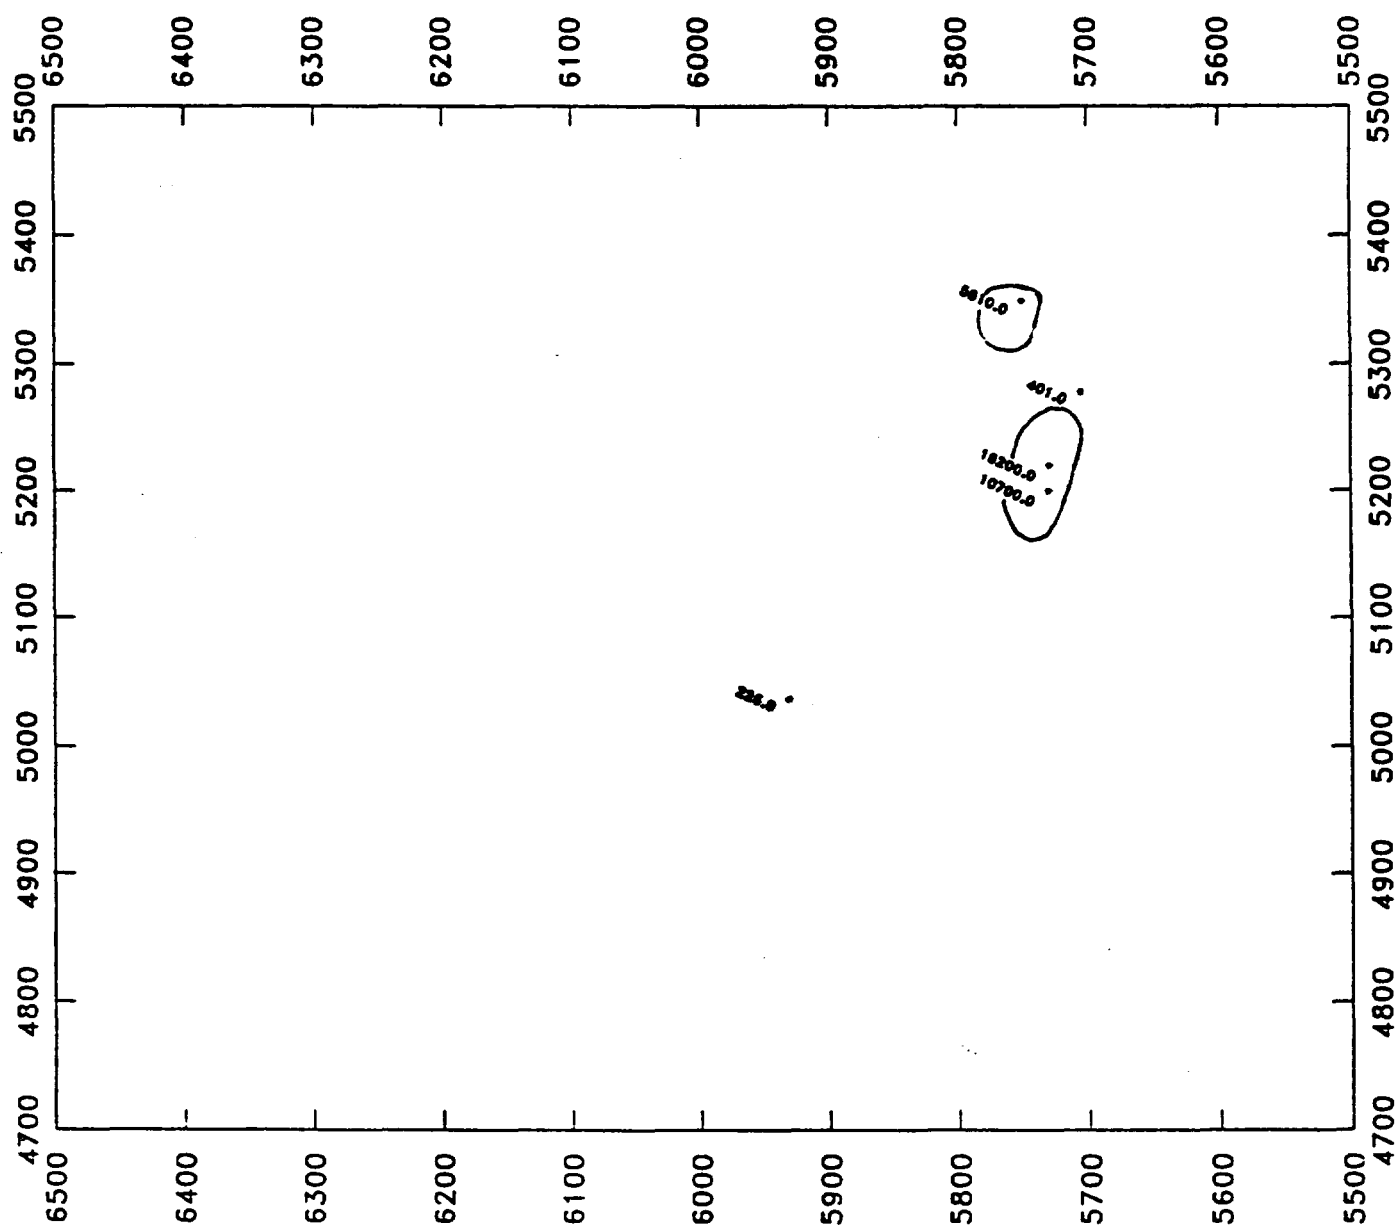
Figure 5-11a Approximate Extent of Lead Containing Wastes (> 500 ppm), Off-Site Areas (1-4 feet below surface). Posted Values are in ppm (mg/kg).

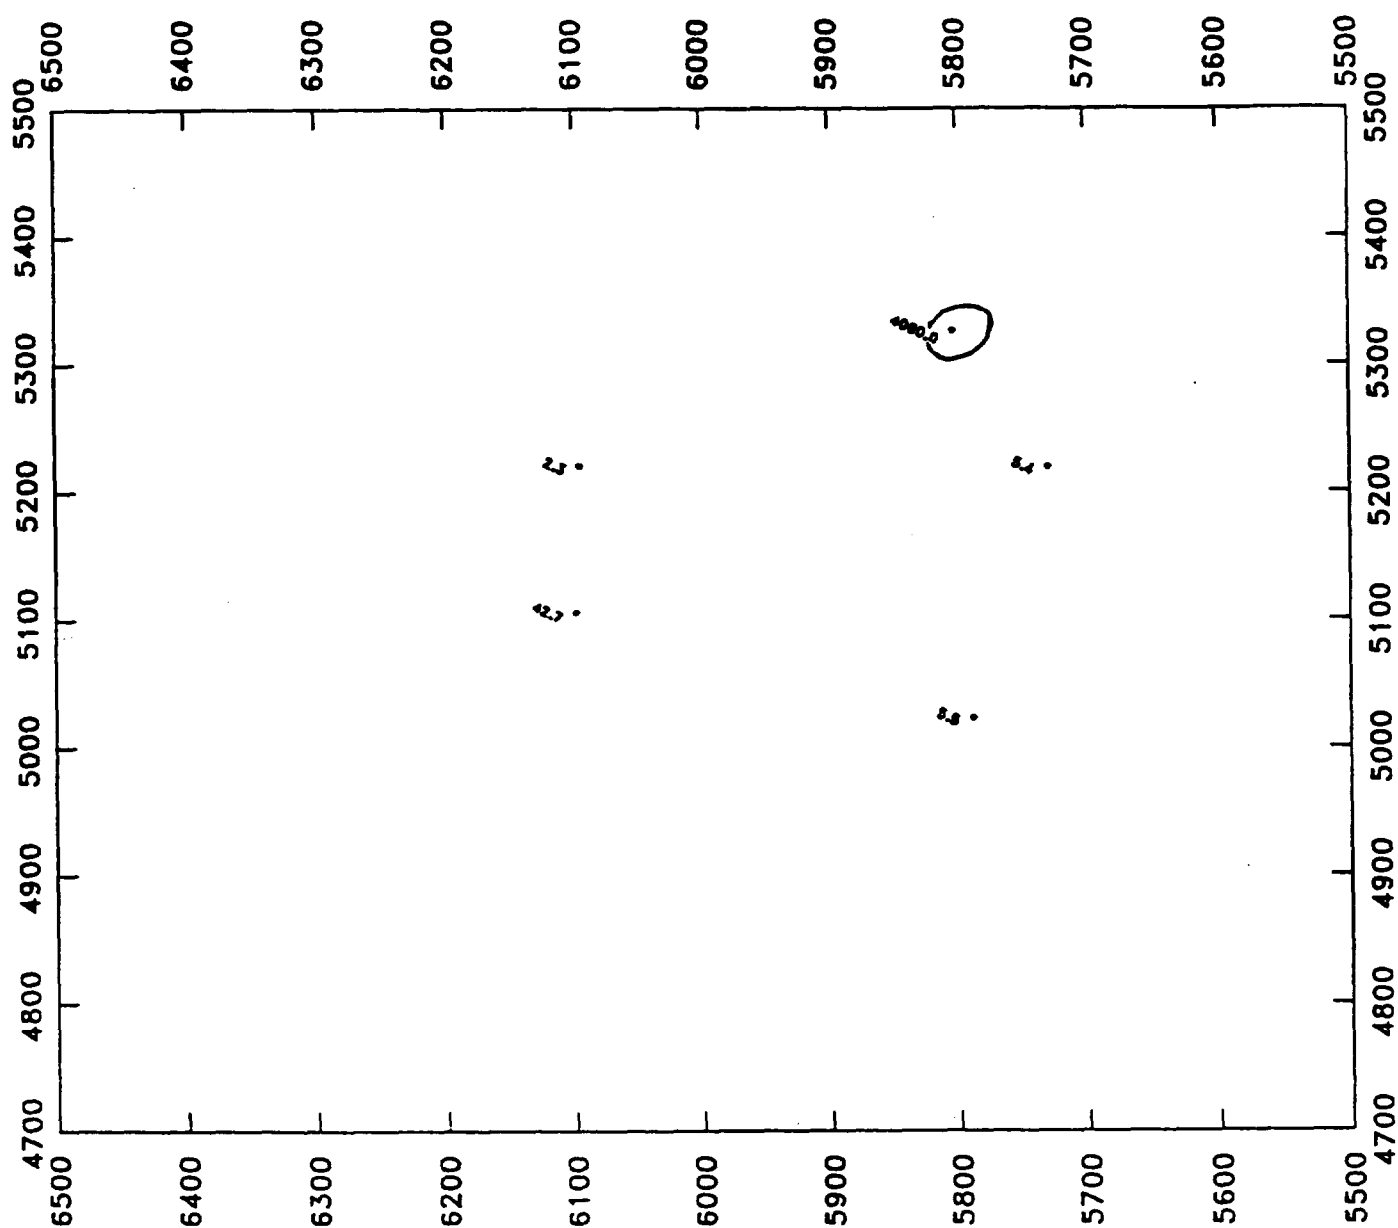
Figure 5-11b Approximate Extent of Lead Containing Wastes (> 500 ppm), Off-Site Areas (4-7 feet below surface). Posted Values are in ppm (mg/kg).

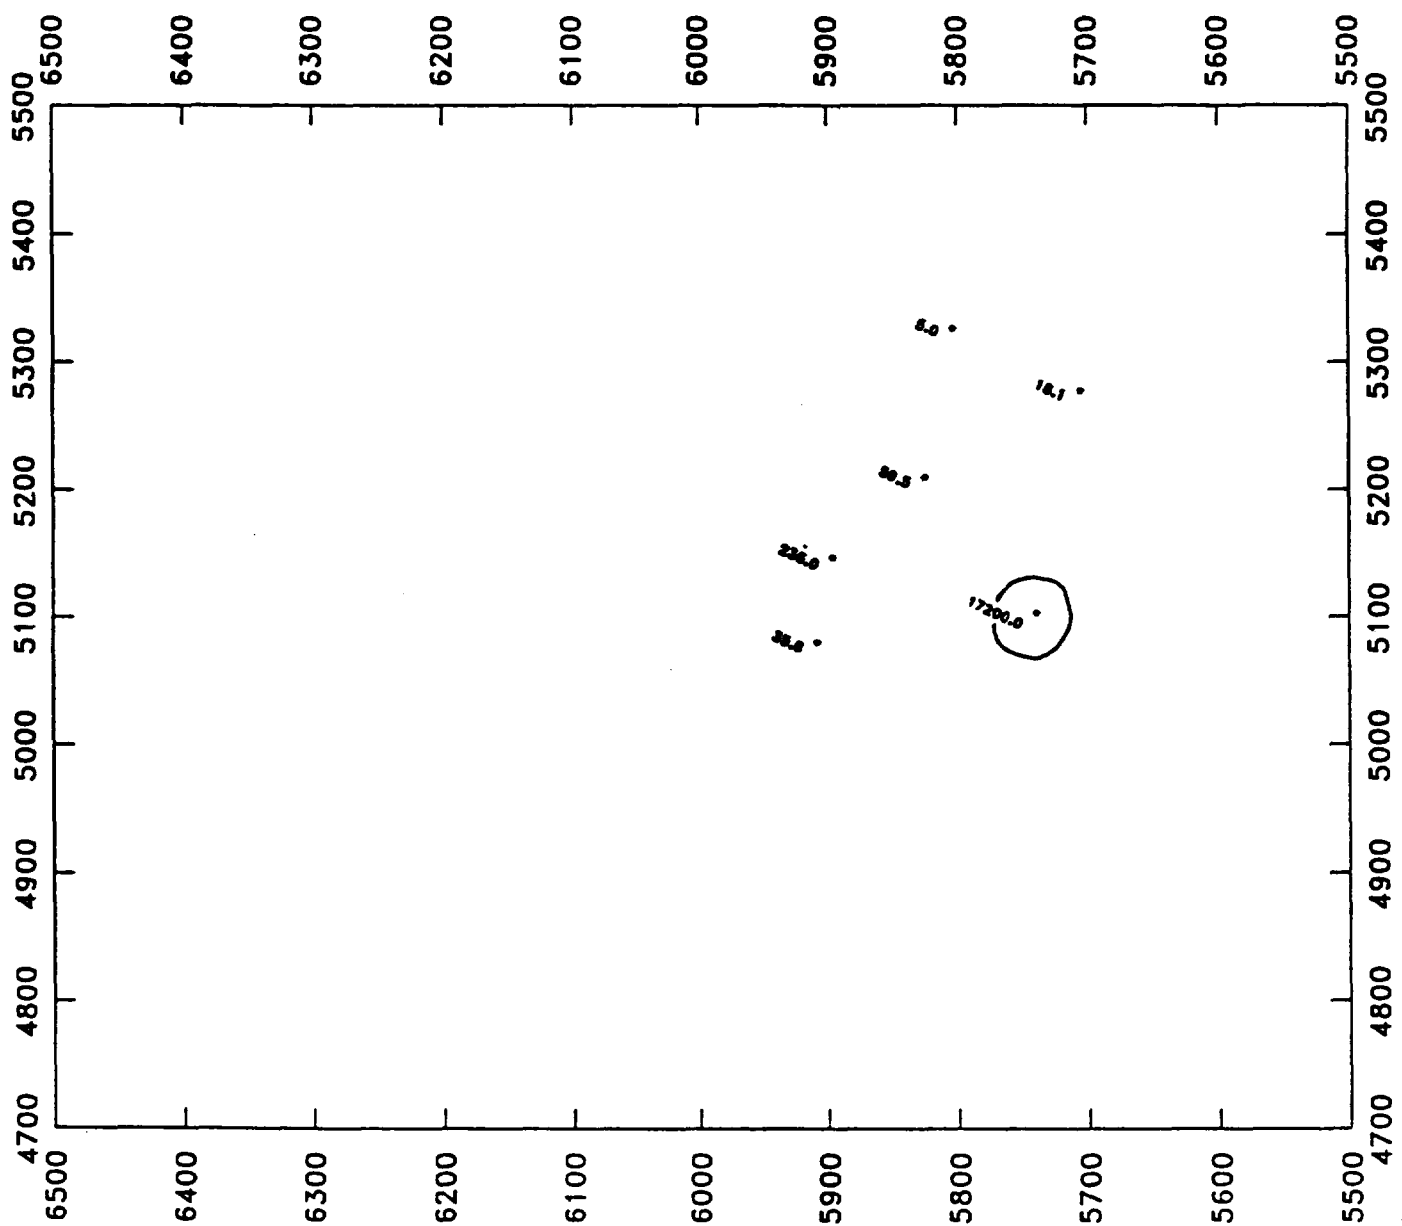
Figure 5-11c Approximate Extent of Lead Containing Wastes (> 500 ppm), Off-Site Areas (7-10 feet below surface). Posted Values are in ppm (mg/kg).

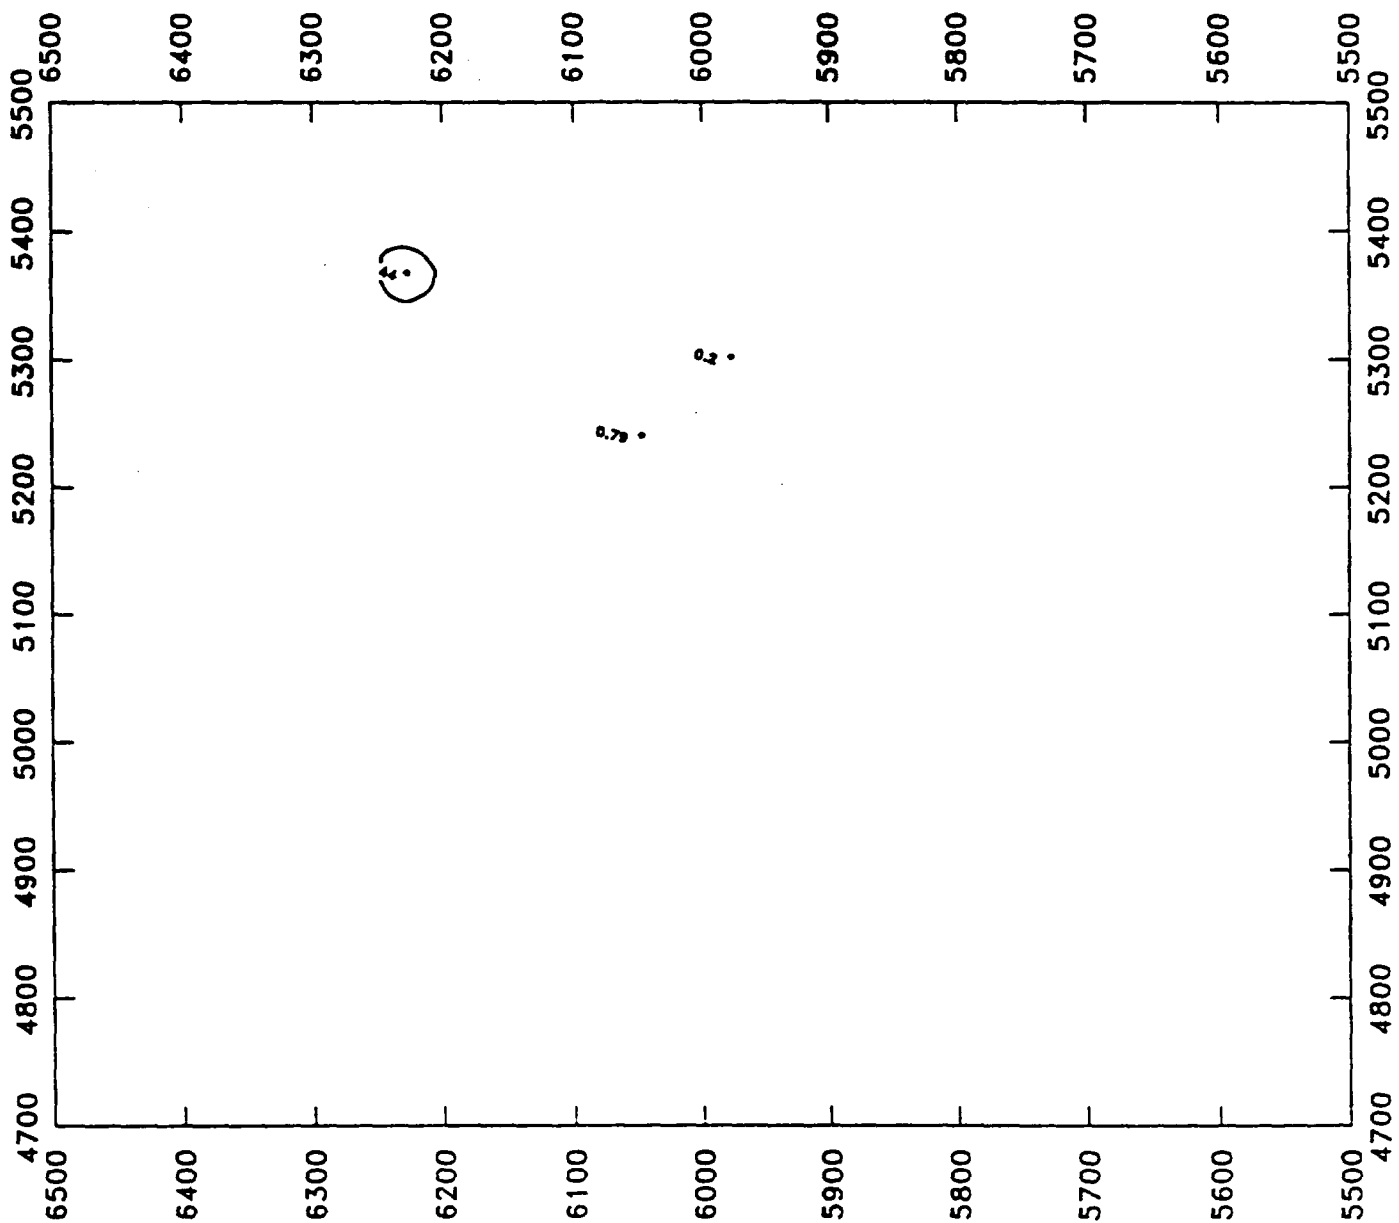
Figure 5-10f Approximate Extent of Total PCB Containing Wastes (> 1 ppm, shaded > 50 ppm), Off-Site Areas (17-20 feet below surface)
